Scott River Riparian Restoration Project

Siskiyou Resource Conservation District

December 22nd 2014

Project Type: Nonpoint Source Implementation

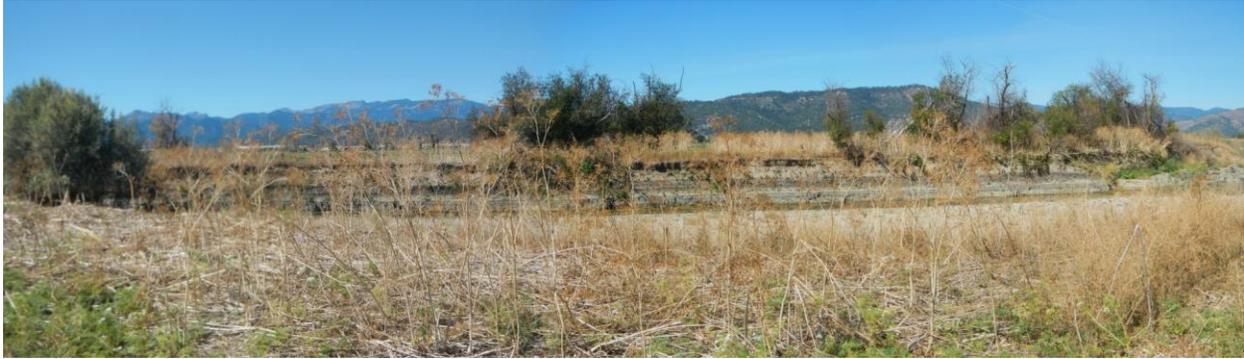
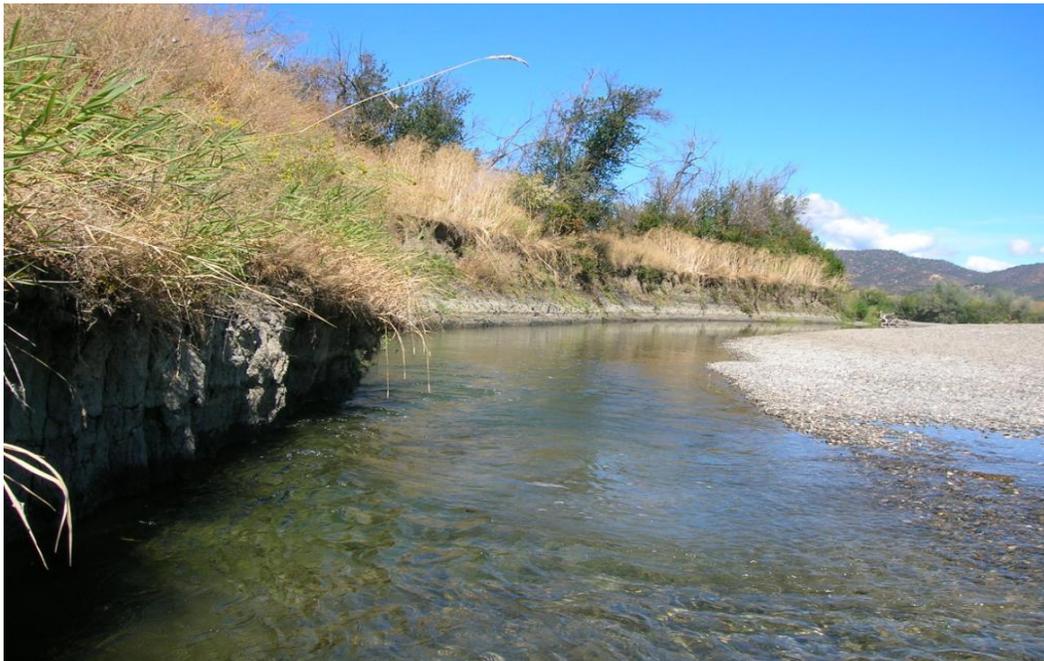
Scott River Bioengineered Streambank Site, River Mile 36 (Hanna Brothers Ranch): Portions of the Scott River between River Mile 29.3 and 41.4 were channelized by the US Army Corp of Engineers in the late 1930's, which has caused a gradual lowering of the riverbed and an ensuing reduction in access to the floodplain. Prior to treatment in 2013, the top of the bank was 12 to 15 feet above the low flow surface elevation and had retreated approximately 30 to 35 feet over the past 17 years. Furthermore, the eroding bank threatened agricultural land, offered little opportunity for the recruitment of natural vegetation, and it is estimated that this location contributed 169 tons of sediment to the Scott River annually.

Photo 1: Bank treatment site at River Mile 36, June 2013 (Siskiyou RCD).

Photo 2: Bank treatment site at River Mile 36, June 2013 (Siskiyou RCD).

To address these issues, a bioengineered streambank stabilization project was completed on this 400-foot section of the west bank during the low flow period of 2013. The bank was graded from the average high water level (2,724 ft.) back at a 3:1 (horizontal:vertical) slope, and a .02-acre section of the overbank was planted with willow poles. Log barbs and stone sills, consisting of large rock and juniper rootwads, were placed at the toe to reduce erosion by shifting the thalweg away from the bank and minimizing helical flow. These instream structures also increased woody complexity and habitat for aquatic species.

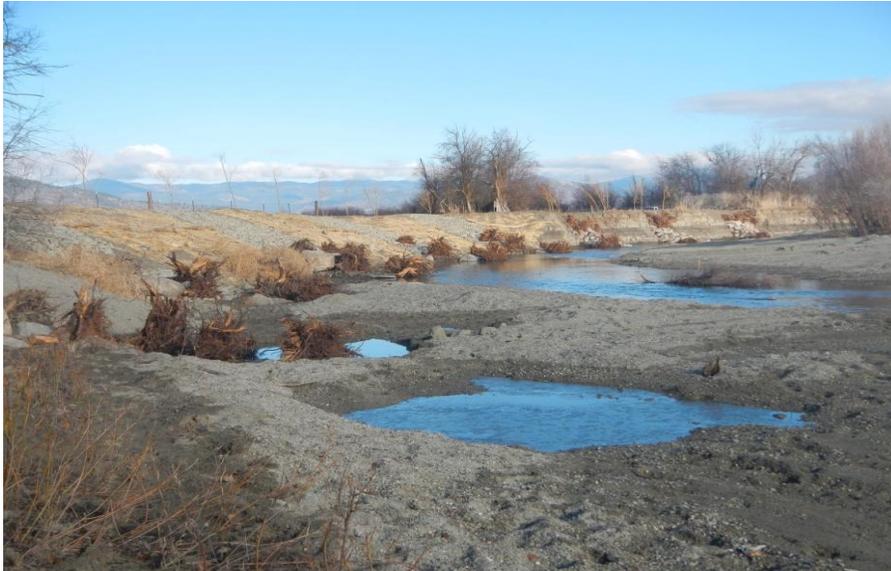
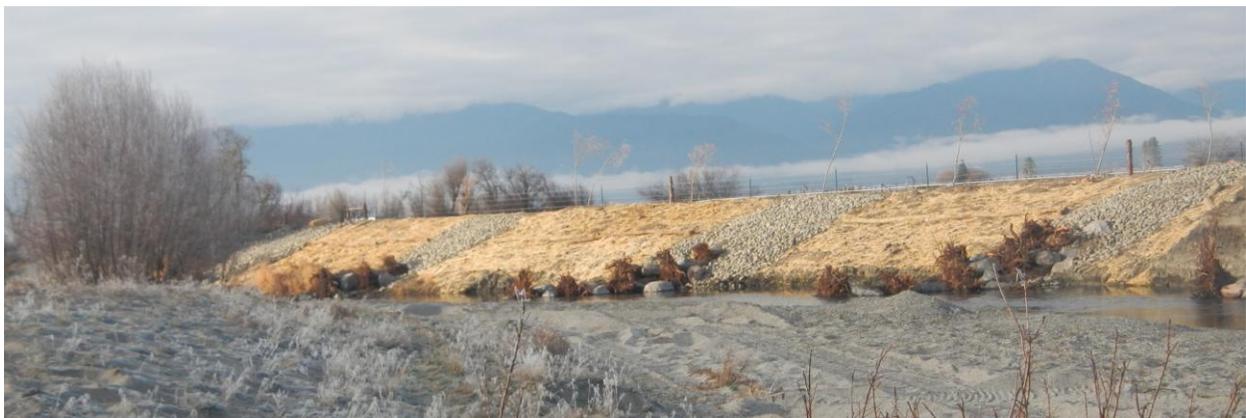
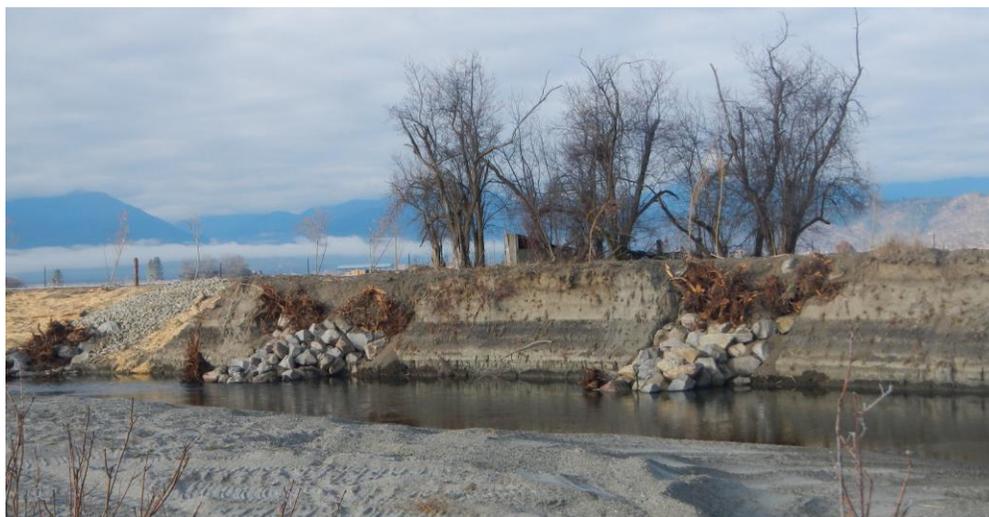
Photo 3: Completed bank stabilization at River Mile 36, November 2013 (Siskiyou RCD).

Photo 4: Completed bank stabilization at River Mile 36, November 2013 (Siskiyou RCD).

Photo 5: Downstream end of completed bank stabilization at River Mile 36, November 2013 (Siskiyou RCD).

Based on erosion volumes calculated from Google Earth images dating back to 1993, the streambank stabilization project at River Mile 36 (Hanna Brothers Ranch) has reduced sediment contribution to the Scott River by approximately 169 tons per year.

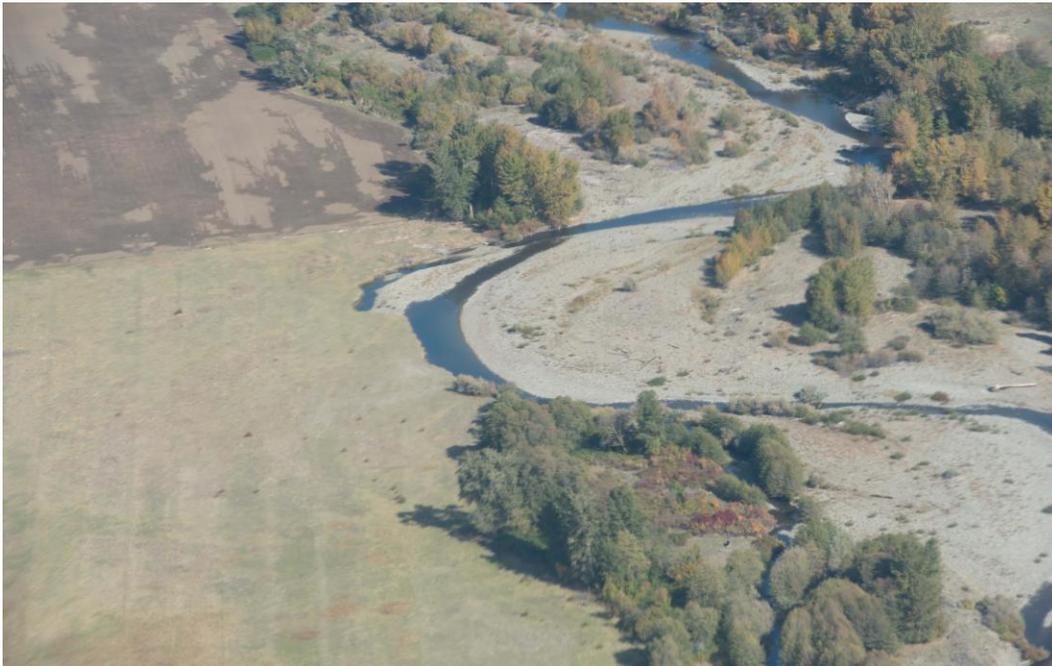
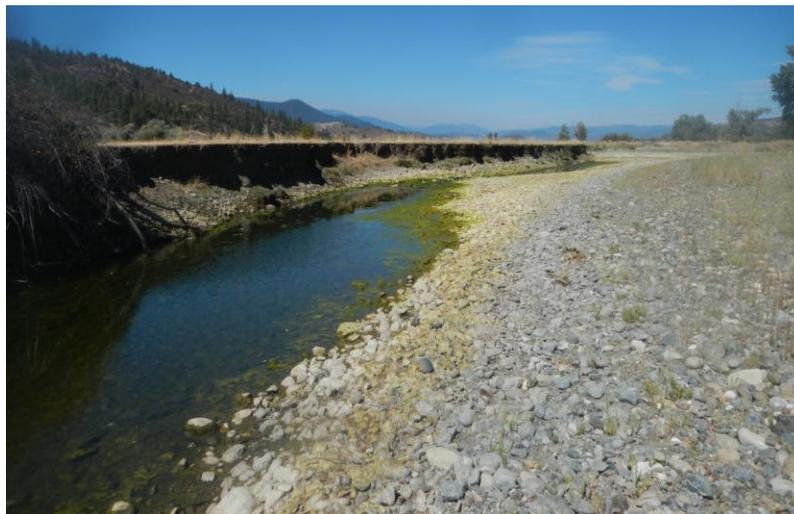
Scott River Bioengineered Streambank Site, River Mile 52 (Merlo Property): This section of the Scott River is located directly downstream of historic mining tailings. The area has a wide meander pattern and a spacious river channel that allows for lateral migration. The active channel width at this site is approximately 800 feet and composed of a gravel and sand streambed with areas of clay exposure. During high flows, the velocities near the bank are very swift and were actively eroding the sand lenses at the toe of the bank, which undermined the above clay layer and led to an estimated 469 tons of sediment contributions per year in a reach that is important to spawning and rearing Chinook salmon, coho salmon and steelhead trout. The continued erosion on the outside of this meander did not only impact adjacent agriculture fields, but it had the potential to flank the downstream riparian corridor and move the river into neighboring properties.

Photo 6: Bank treatment site at River Mile 52, November 2013 (Joey Howard).

Photo 7: Bank treatment site, looking downstream, September 2014 (Siskiyou RCD)

The objectives of this design are to reduce streambank erosion by pushing the thalweg off the bank with the installation of anchored log barbs (six total) and engineered log jams (eight total). The project also addresses a secondary and highly erosive cusp, near the downstream end of the bank, with similar treatments. In addition, a complete revegetation of the 0.6-acre site was completed post construction to enhance the existing riparian corridor and establish trees to supply shade to the river. Thirty cottonwood pole cuttings were planted along the top of the bank, and up to forty vertical willow bundles were buried between each of the instream log barbs. Photo points will be revisited annually when vegetation is fully leafed out (July) and counts will be made to evaluate survival. A 50-70 % survival rate is anticipated. A total of 2,800 feet of riparian exclusion fencing will be installed along the mainstem Scott River at River Mile 52 (Merlo Property) in early January of 2015.

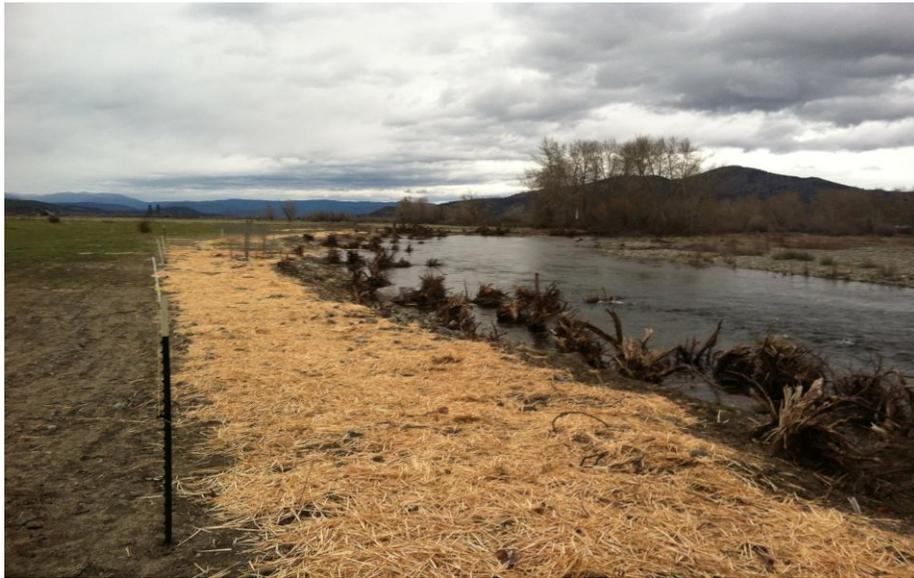
Photo 8: Completed bank stabilization at River Mile 52 looking downstream, December 2014 (Siskiyou RCD).

Based on erosion volumes calculated from Google Earth images dating back to 2005, the streambank stabilization project at River Mile 52 (Merlo Property) has reduced sediment contribution to the Scott River by approximately 469 tons per year.

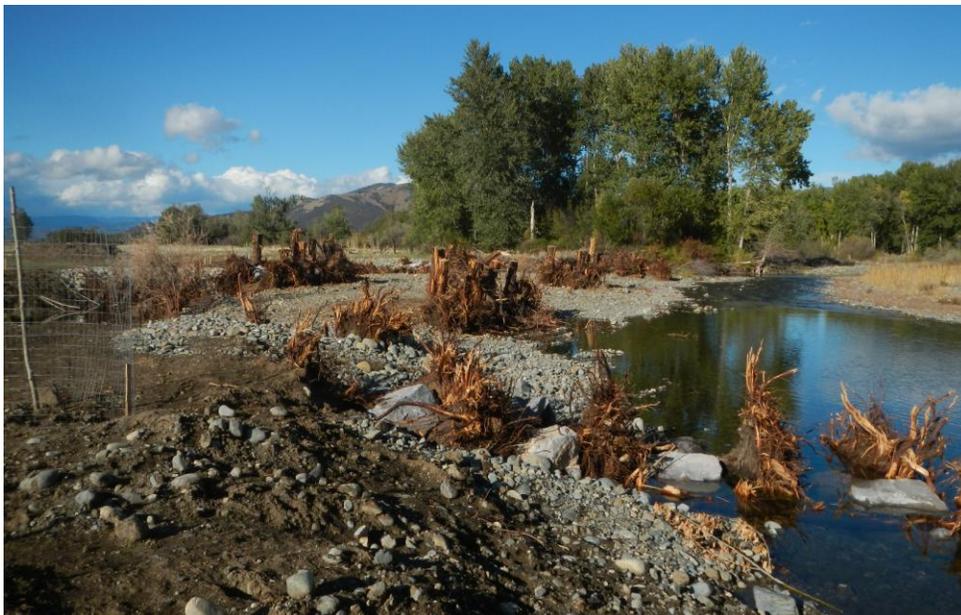
Photo 9: Stabilization of secondary cusp, November 2014 (Siskiyou RCD).

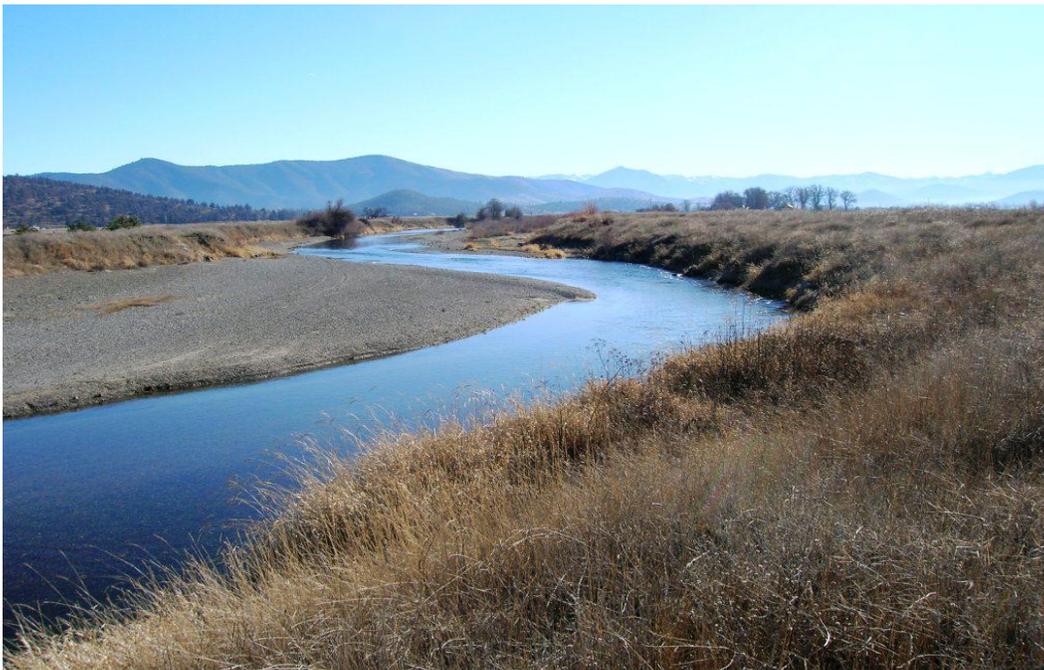
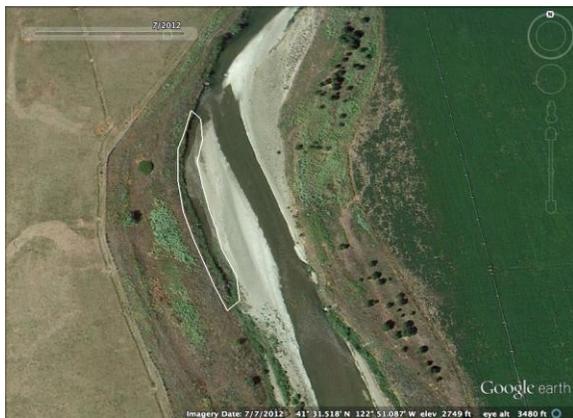
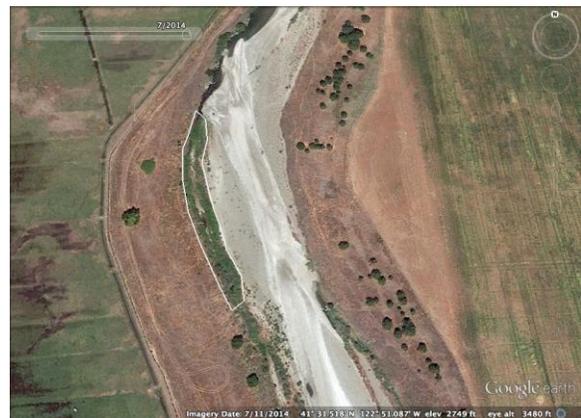
Photo 10: Pre-planting view of River Mile 38 revegetation site, February 2013 (Siskiyou RCD).

Image 2: River Mile 38, 2012 (Google Earth Imagery)

Image 3: River Mile 38, 2014 (Google Earth Imagery)

Despite a dry riverbed during the drought of 2014, vegetation is visibly greater in the treated area and a 60% survival estimate has been determined.

In the spring of 2013, a 0.3-acre site on the west bank was planted with approximately 80 willow cuttings (golden, red, and arroyo varieties). The plantings were installed in two rows, on the mid level of the slope, for the purpose of bank stabilization and shading of the stream channel.

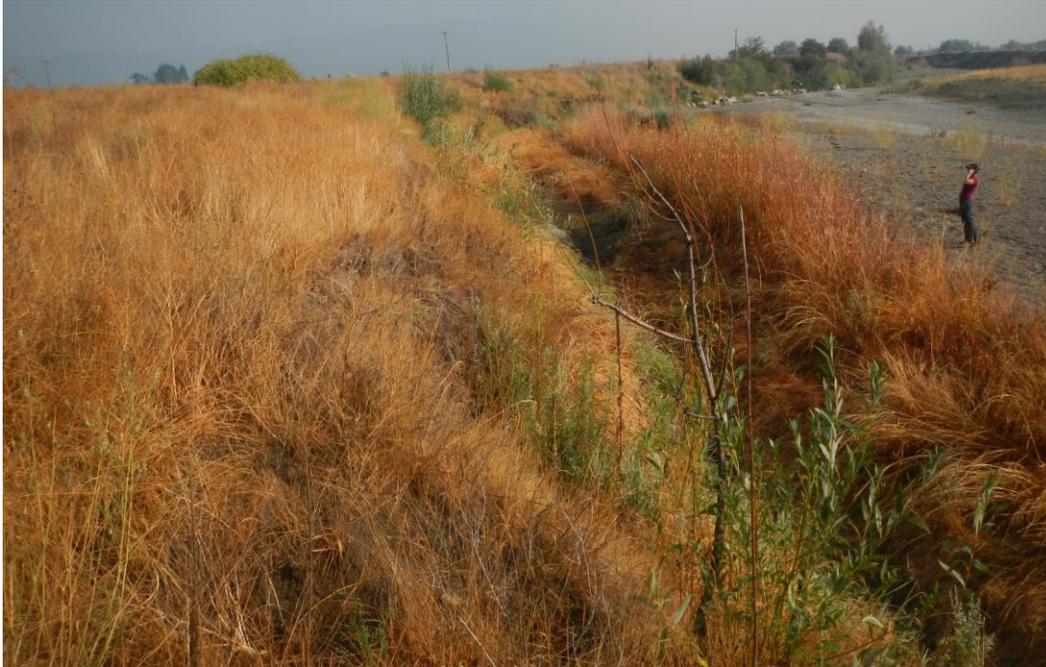
Photo 11: Downstream view of willow plantings at River Mile 36, July 2013 (Siskiyou RCD).

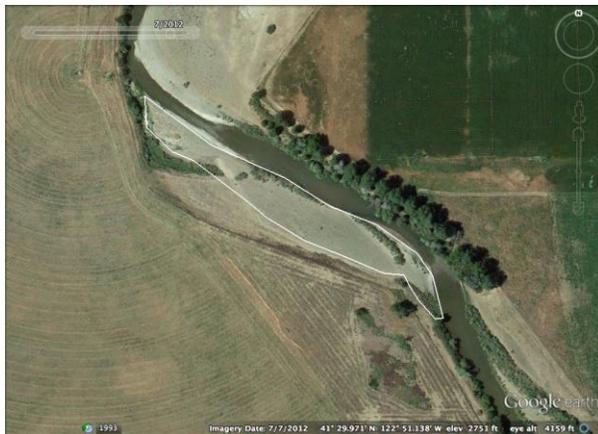
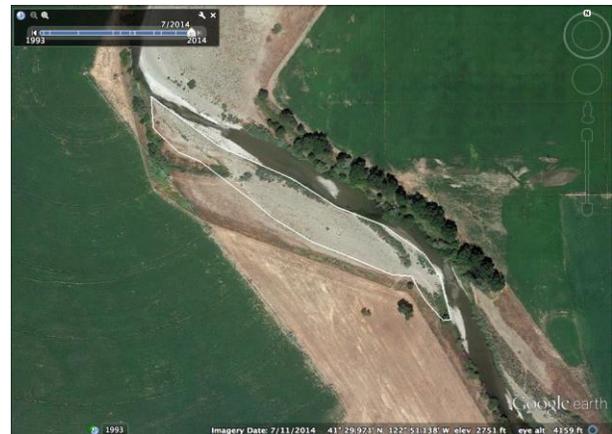
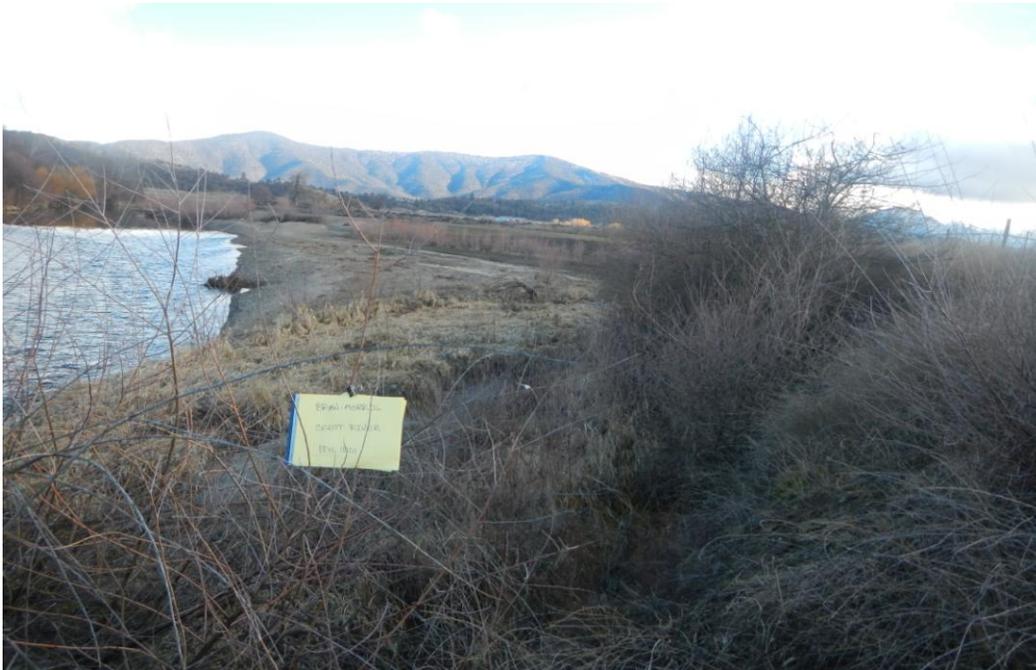
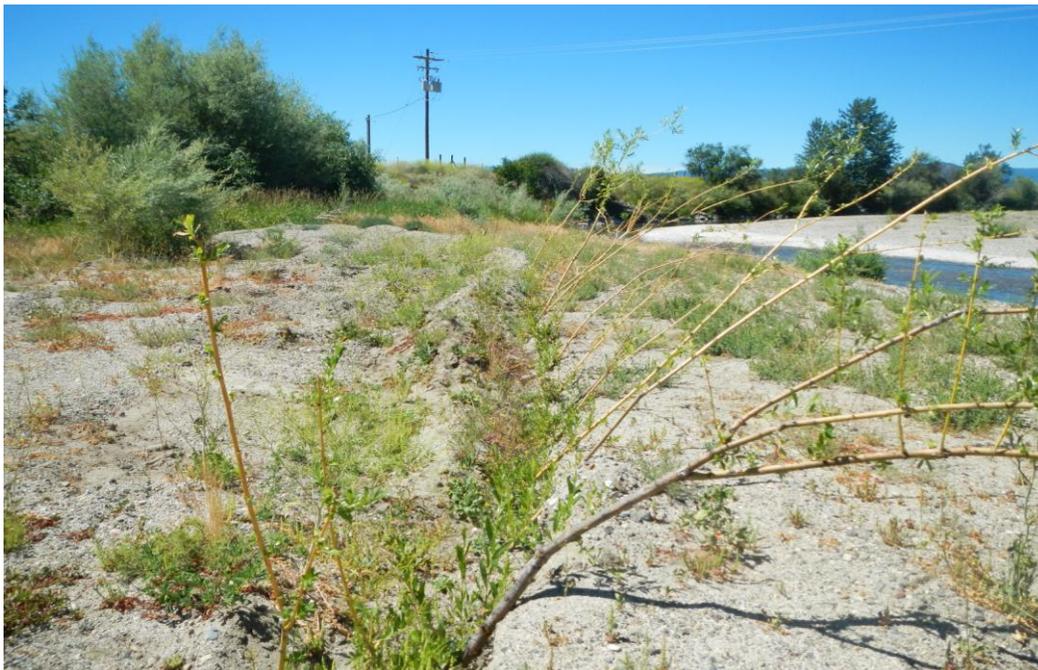
Image 4: River Mile 40, 2012 (Google Earth Imagery)

Image 5: River Mile 40, 2014 (Google Earth Imagery)

Photo 12: Pre-implementation view of riparian planting site at River Mile 40, February 2013 (Siskiyou RCD)

Photo 13: Trench plantings on the northern end of the gravel bar, June 2014 (Siskiyou RCD).

Riparian Planting, River Mile 40 (Bryan-Morris Ranch): Plantings were installed at this site in an effort to revegetate the gravel bar on the west bank. This bank is ideal for providing canopy cover to the Scott River due to its southern orientation. A 2.1-acre site on the west bank was planted with golden willow poles harvested from the eastside of the river. Approximately 75 pole cuttings were planted down to the existing water table in the spring of 2013. Several different methods were used, including trench plantings and cuttings interspersed with existing vegetation (sandbar willows). Survival has been documented at just over 60% at this gravel bar. The trench plantings on the Northern end of the site are visible in the aerial images below.

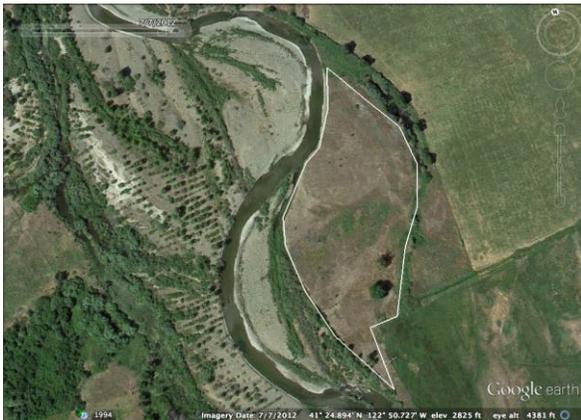
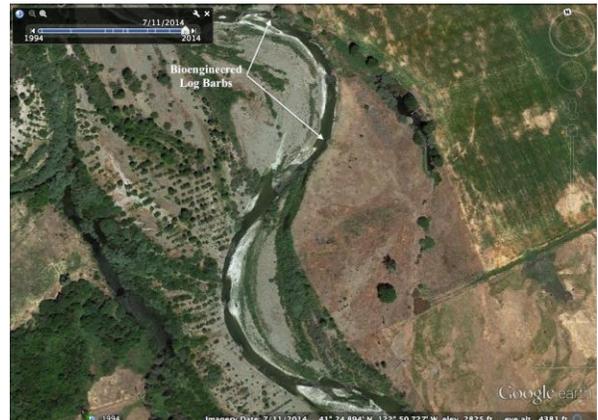
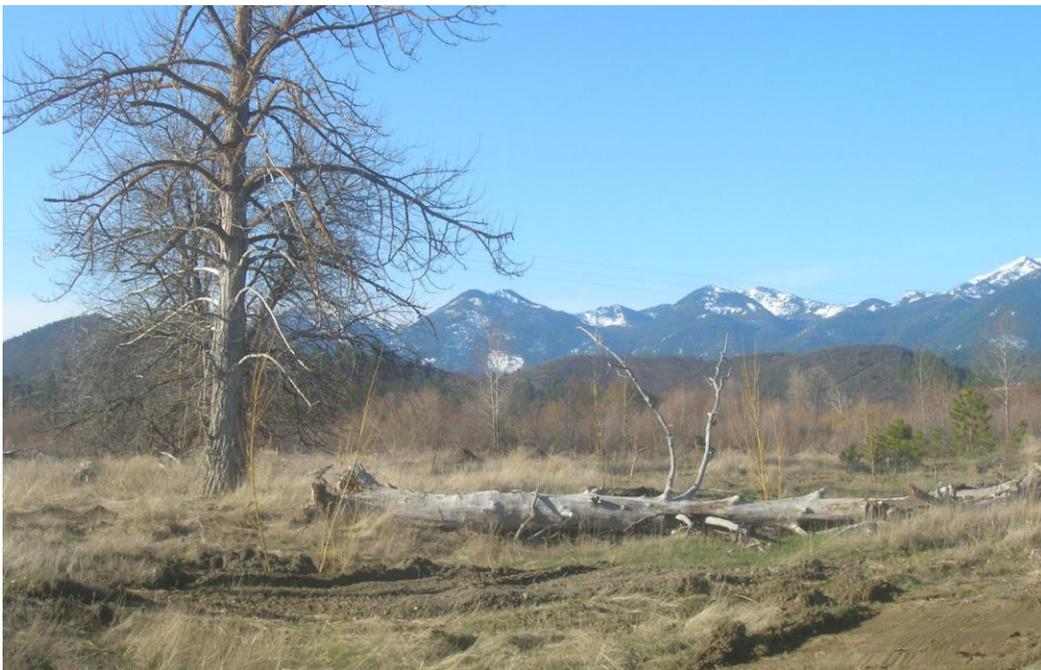
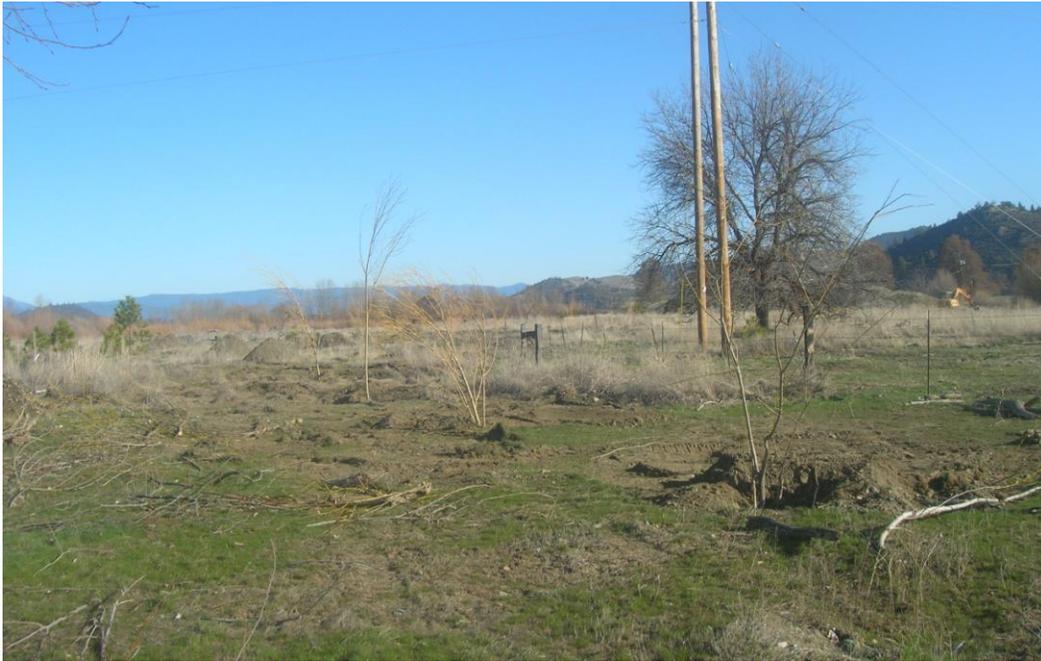
Image 6: River Mile 48 East Bank, 2012 (Google Earth Imagery)

Image 7: River Mile 48 East Bank also showing boundaries of bank stabilization project, 2014 (Google Earth Imagery).

Photo 14: Pole plantings on the East bank at River Mile 48, April 2013 (Siskiyou RCD).

Photo 15: Pole plantings on the East bank at River Mile 48, April 2013 (Siskiyou RCD).

A 5.51-acre section of the east bank was planted in April of 2013 with 95 cottonwood poles and 14 willow clumps. While nearly all of the willow clumps survived, the combination of heavy browsing by elk in the area and extreme drought resulted in poor survival of the cottonwood poles (estimated at 10 %). Therefore, this area was replanted with a 35 black cottonwood poles in October of 2014. Additionally, approximately 30 vertical willow bundles were planted in between each of the last four upstream log bars. Photo points will be revisited annually when vegetation is fully leafed out (July) and counts will be made to evaluate survival of this second round of planting.

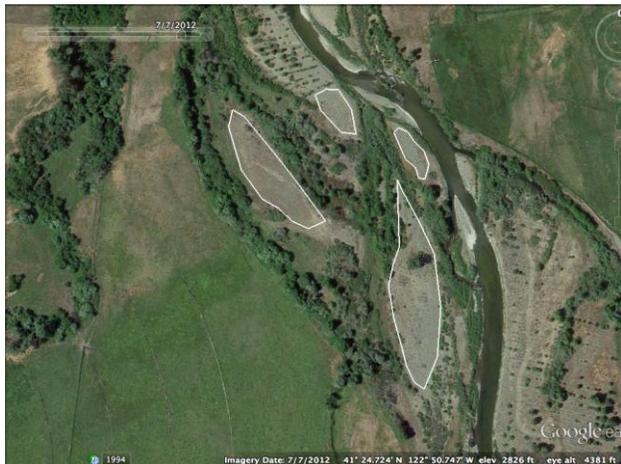
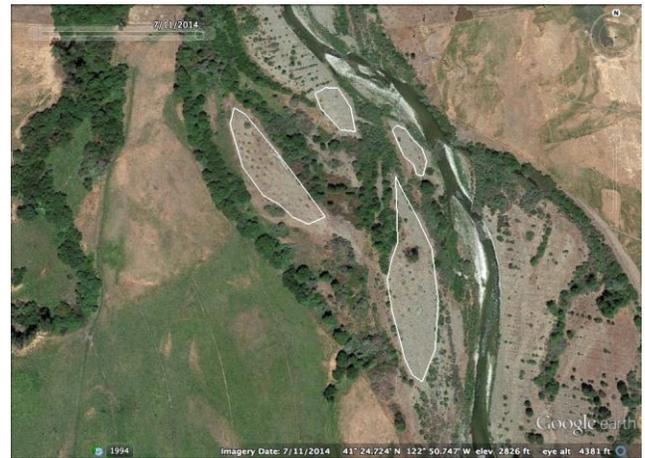
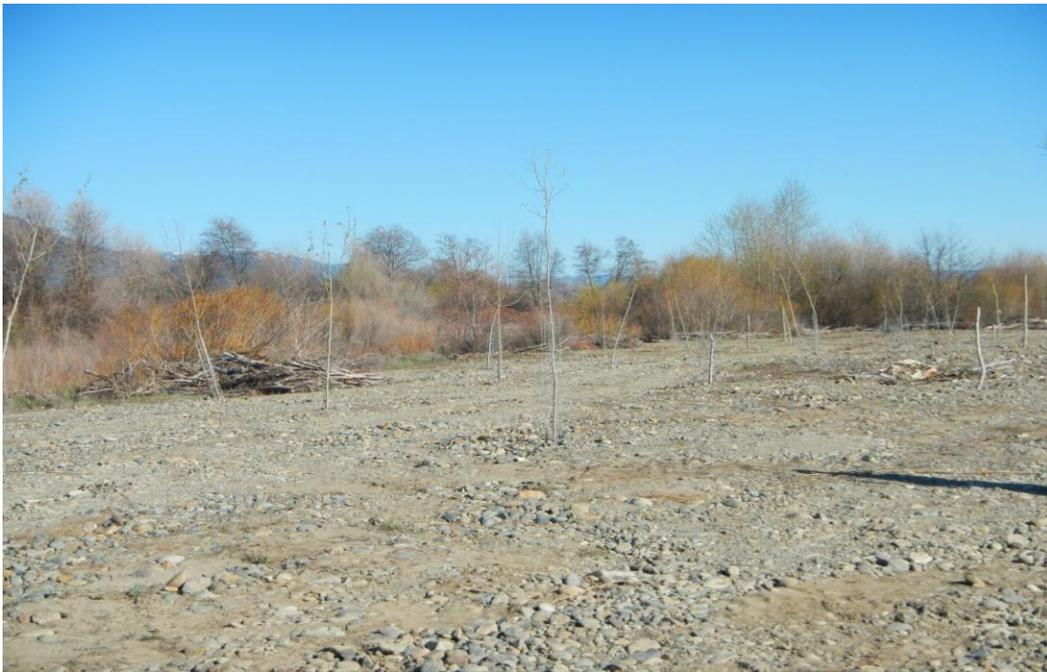
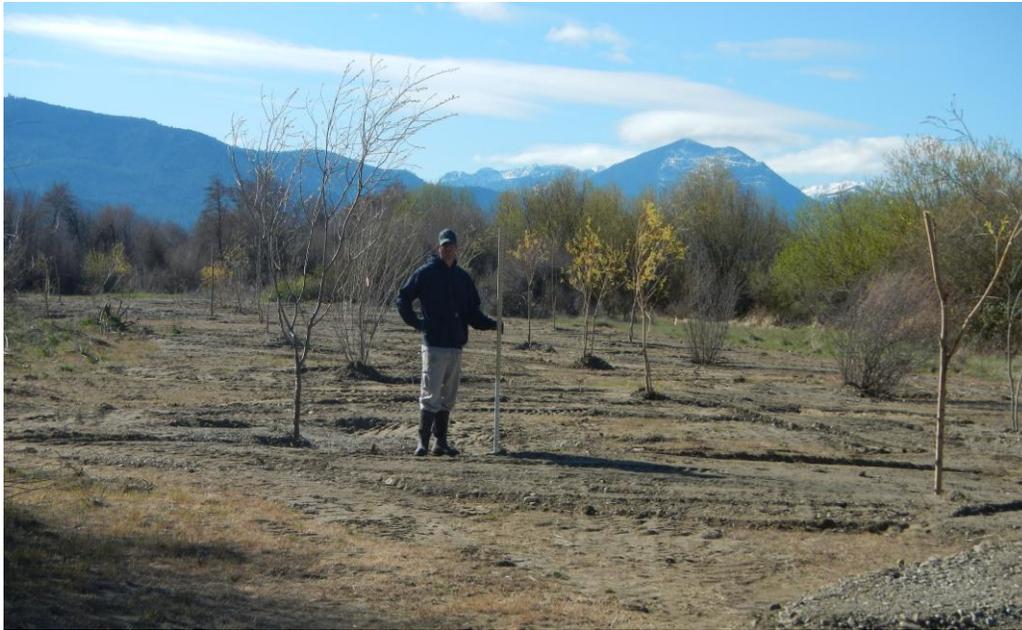
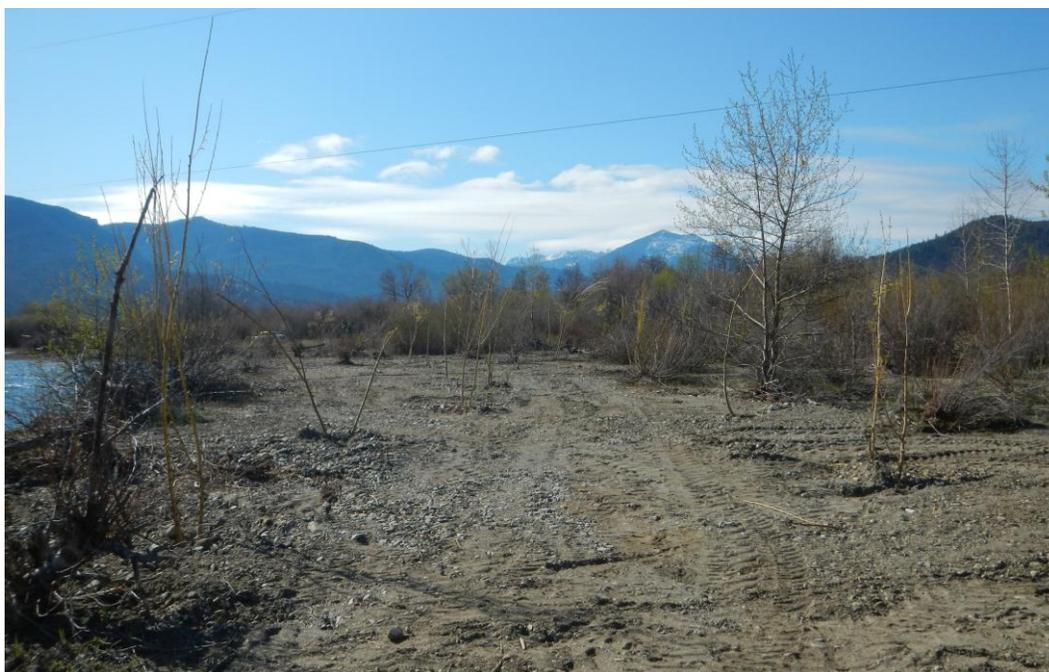
Image 8: River Mile 48 West Bank, 2012 (Google Earth Imagery)

Image 9: River Mile 48 West Bank, 2014 (Google Earth Imagery).

Photo 16: Pole plantings at River Mile 48, April 2013 (Siskiyou RCD).

Photo 17: Pole plantings at the River Mile 48 West Bank site, May 2013 (Siskiyou RCD).

Photo 18: Pole plantings at the River Mile 48 West bank site, May 2013 (Siskiyou RCD).

Four distinct sites on the west bank were planted in the spring 2013. They were chosen to expand on successful nearby plantings and fill in remaining open areas within the riparian zone. Overall survival on the West Bank has been estimated at 65%.

- i. A 0.8-acre section near the Wolford Slough was planted with cottonwood poles and a variety of willow clusters and bundles (coyote willow, pacific willow, golden willow), all sourced from nearby locations. There were 46 total plantings at this site.
- ii. A 1.13-acre section was planted with mostly cottonwood poles (75 total) and a few willow clumps.
- iii. A 0.15-acre section near the river was planted with a total of 53 mixed pole cuttings (cottonwood, pacific willow, golden willow) and a few willow clumps. Heavy beaver activity in the area has affected survival.
- iv. A 0.21-acre section was planted with 22 black cottonwood poles.
