# Rancho Del Sol Revegetation Plan

The Rancho del Sol Streambank Stabilization Project is located on the Scott River at river kilometer (rkm) 67 (PLSS Township 42 N Range 09 W, Section 14 NE ¼). The project area encompasses a 15 acre section of the floodplain from a private bridge to the downstream property line. To access the site, depart from Main Street in Etna, cross State Highway 3 onto Island Road, and travel 2.9 miles to 2914 Island Road. Turn right into Rancho del Sol and proceed 0.8 miles down a dirt road to the private bridge that crosses the Scott River. The project site is immediately downstream. The property owner must be notified before visiting the site.

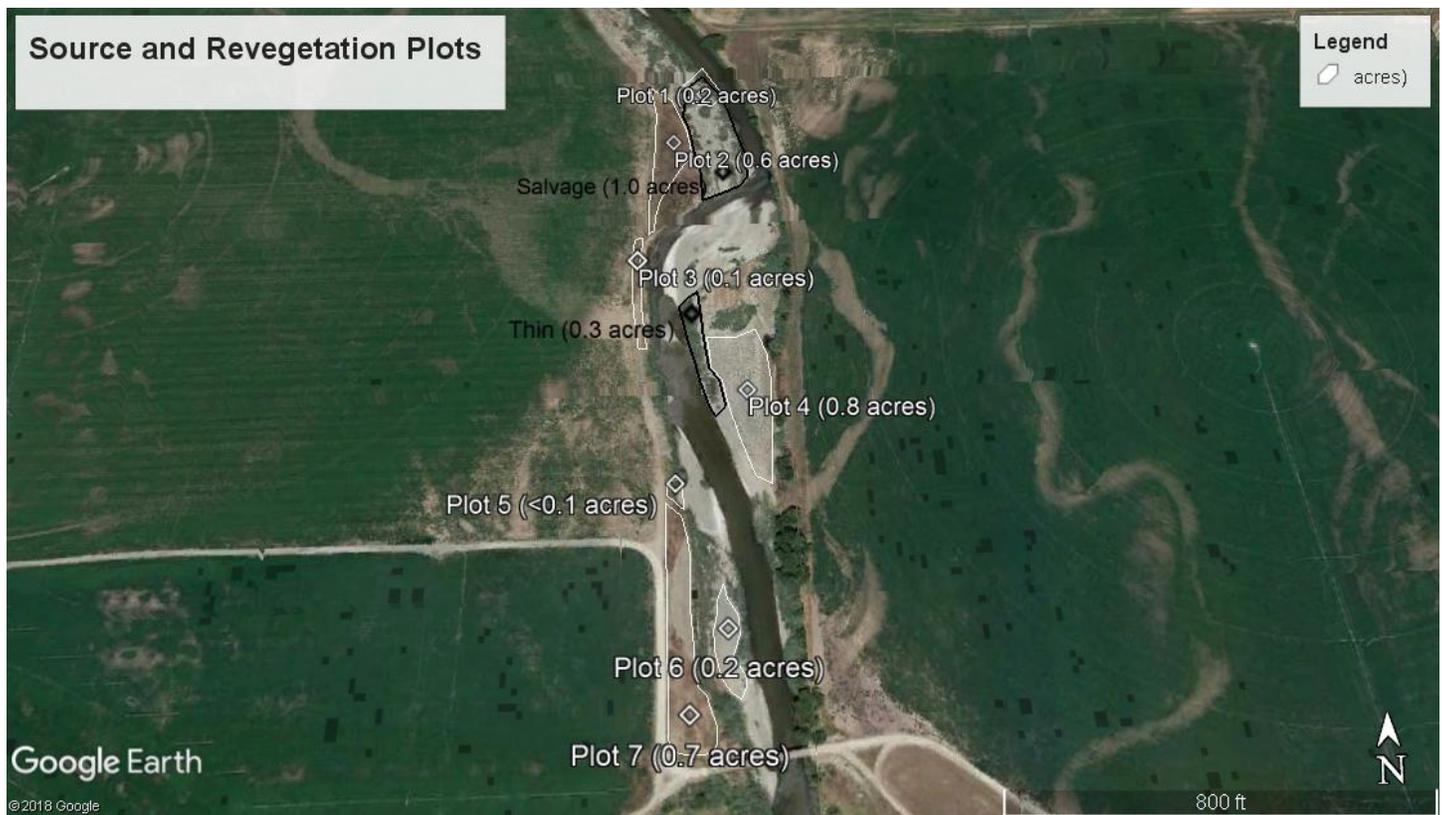
**Figure 2. Preliminary identification of revegetation plots**

- Willow bundles will be planted within and between all ELJ structures.
- Willow bundles and willow clumps will be planted along the toe of eroding banks.
- Willow bundles will be planted into the banks of the newly excavated overflow channels near where they enter the main channel (Plot 1)
- Willow clumps will be planted into the lower terraces and floodplain in rows running parallel with the direction of flow (Plots 4 & 6)
- Willow bundles will be planted in an eroding cusp on the river left bank upstream from the treatment site (Plot 5)

To provide greater canopy cover and stream shading upon plant maturation, cottonwood poles, and, if applicable, pine plugs will be planted along the tops of banks (Plot 3), across the western terrace above the floodplain grading (Plot 1) and across the western terrace below the bridge (Plot 7). Cottonwoods and pines will be harvested off-site.

The gravel bars and the entrance to the newly constructed overflow channels will not be planted so as not to impede flow (identified as a Salvage site).

- Native willows salvaged from the project site and collected from dense willow stands on the property (“Salvage” and “Thin” plots in Figure 2). Whole willows will be acquired with the roots intact (clumps). Willow cuttings with a minimum diameter of 1/4 inch and length of about 18-40 inches and will be bundled for planting (bundles). Willow cuttings with a minimum diameter of 1/2 inch will be left in water for use as pole plantings (poles).
  - *Salix lucida* (pacific willow)
  - *Salix exgua* (sandbar willow)
- *Populus trichocarpa* (black cotton wood) poles, harvested off-site.
- *Pinus ponderosa* (ponderosa pine), purchased as plugs.
